RIVER AUX VASES BASIN
BUTTERFLY AND RAINBOW LAKES
STE. GENEVIEVE COUNTY, MISSOURI

MISSOURI INVENTORY NOS.
BUTTERFLY LAKE MO. 30501
RAINBOW LAKE MO. 30641

PHASE I INSPECTION REPORT
NATIONAL DAM SAFETY PROGRAM

SEPTEMBER 1978

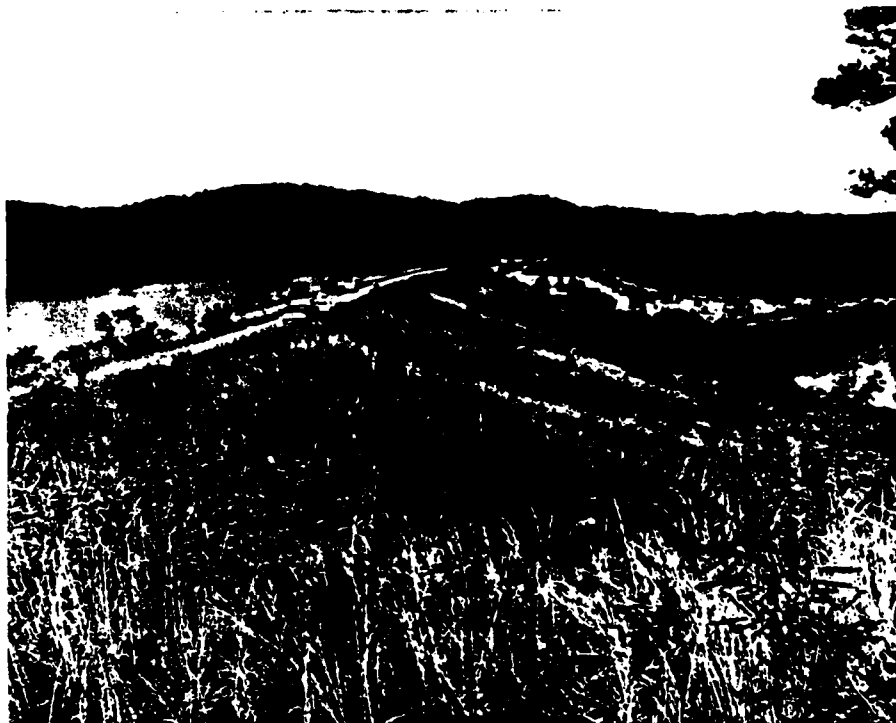
PHOTO 1

Butterfly Dam

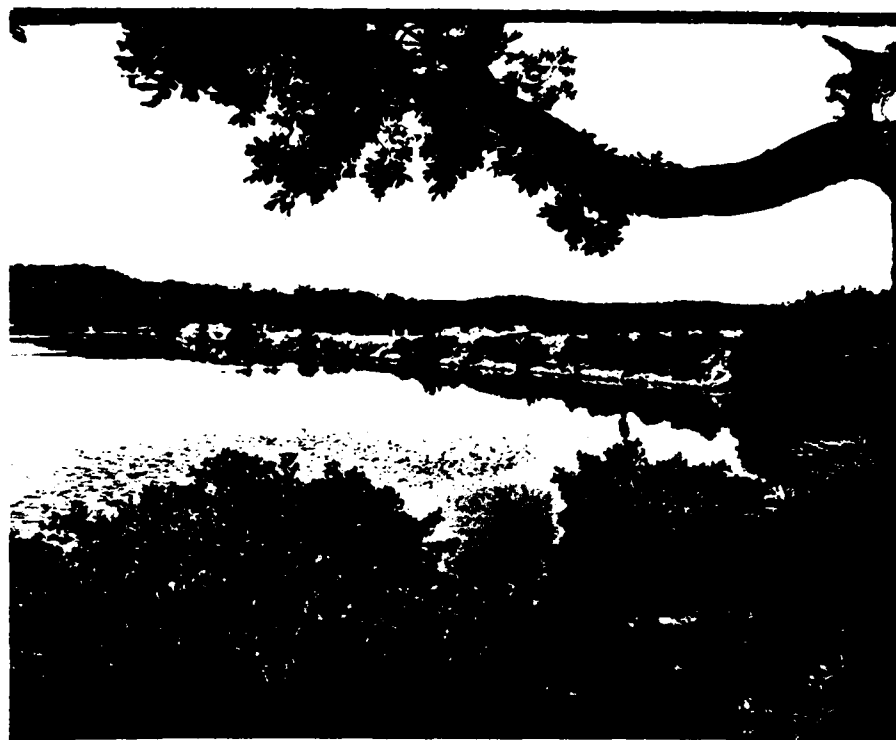
PHOTO 3 Butterfly Dam - Upstream
Slope

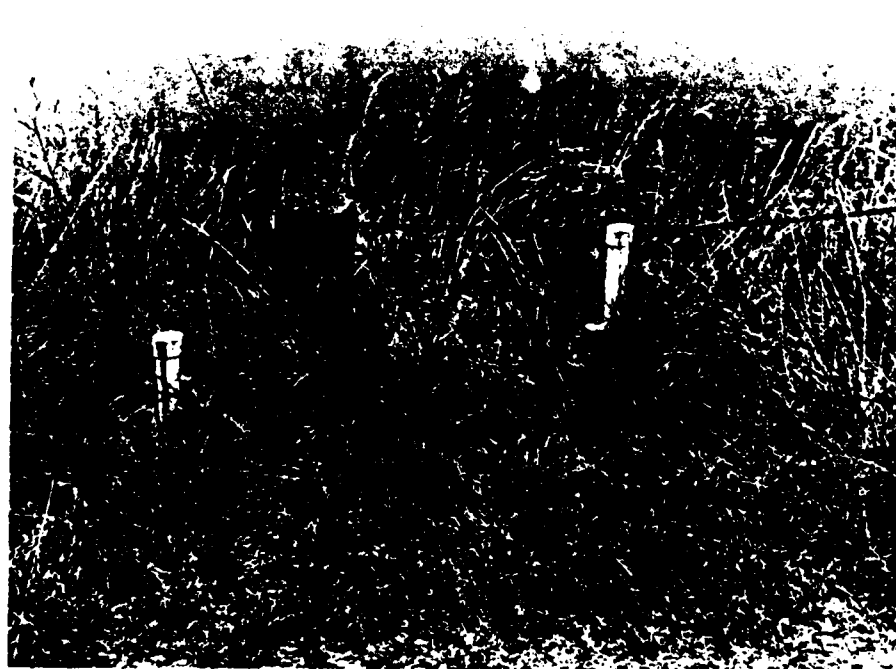
PHOTO 4 Butterfly Dam - Piezometers

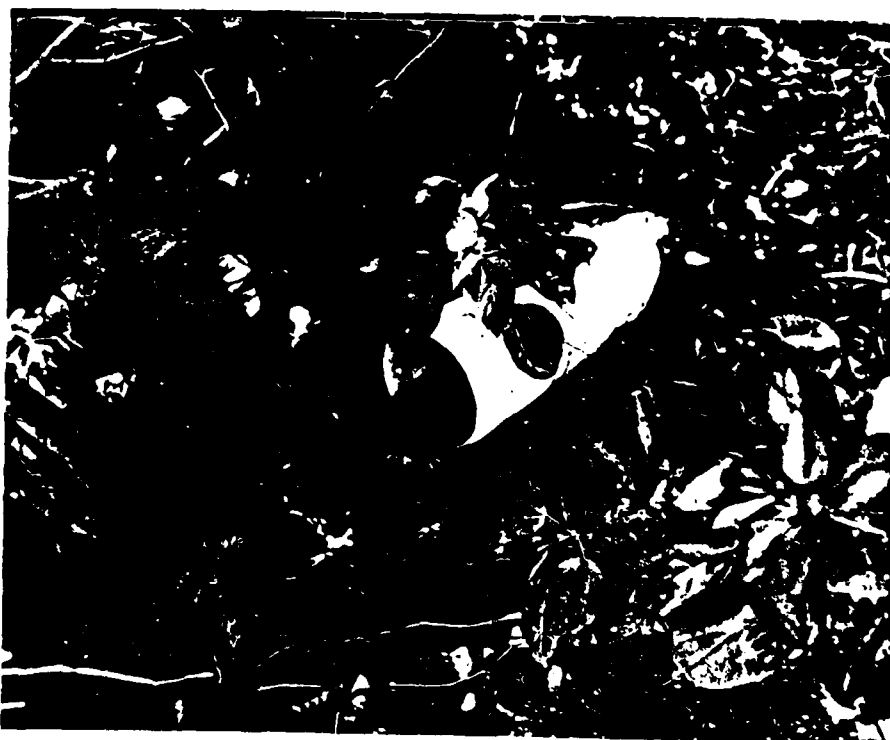
PHOTO 6 Butterfly Dam - Drainage
System Outlet

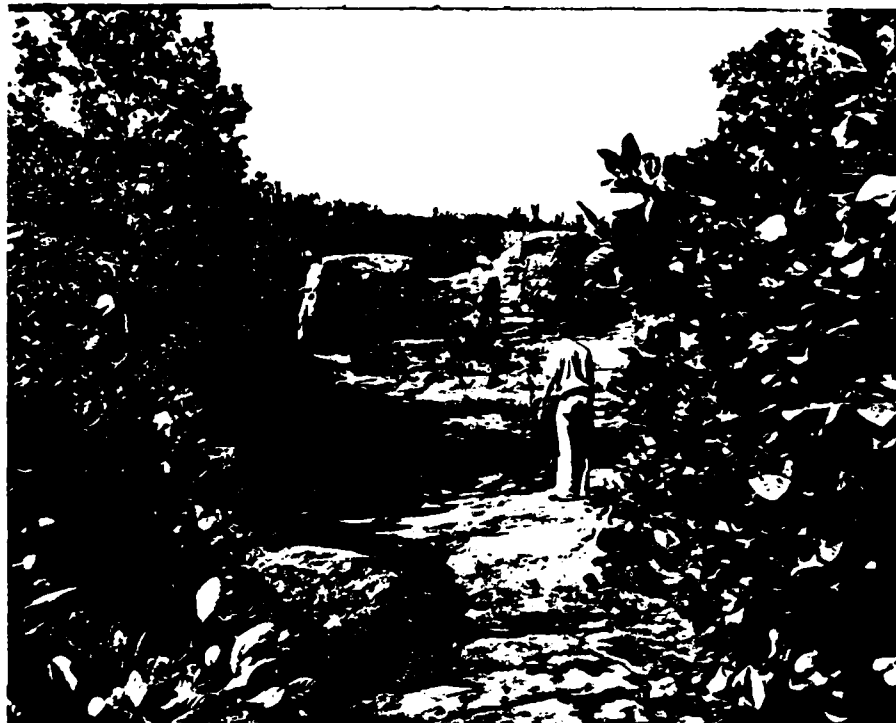
(a) The outlet works for Butterfly Lake consists of six 24-inch corrugated metal pipes located at the left end of the dam embankment. The inlet invert elevation is at 802.15 feet. The outlet invert is at 801.71 feet. The tailwater flows through a steep channel cut through rock in the left abutment of the dam. The inlet and outlet of the culvert spillway are protected by concrete head-and-wing walls. Some erosion was noted at the right hand downstream wing wall. The owner's representative stated an intention to provide future protection. (See photographs 7 and 8.)

PHOTO 7 Butterfly Dam - Outlet Channel

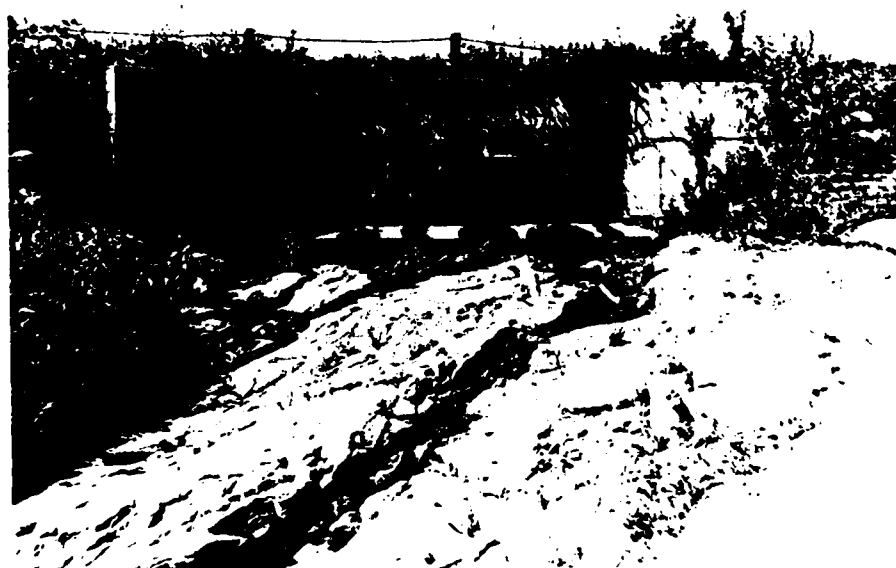
PHOTO 8 Butterfly Dam - Outlet

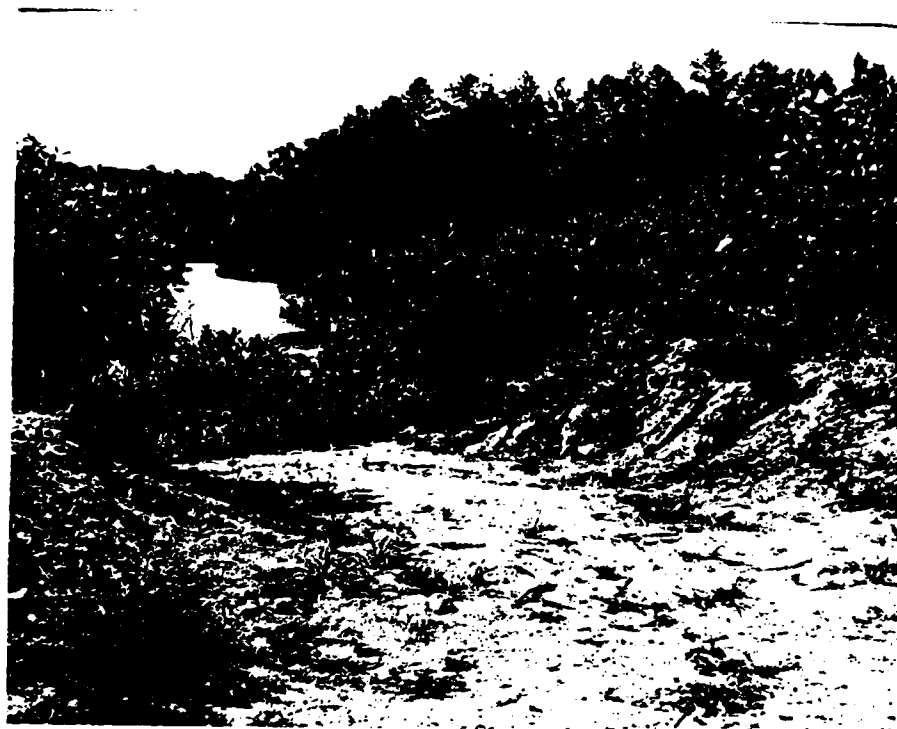
PHOTO 2 Butterfly Dam - Emergency
Spillway

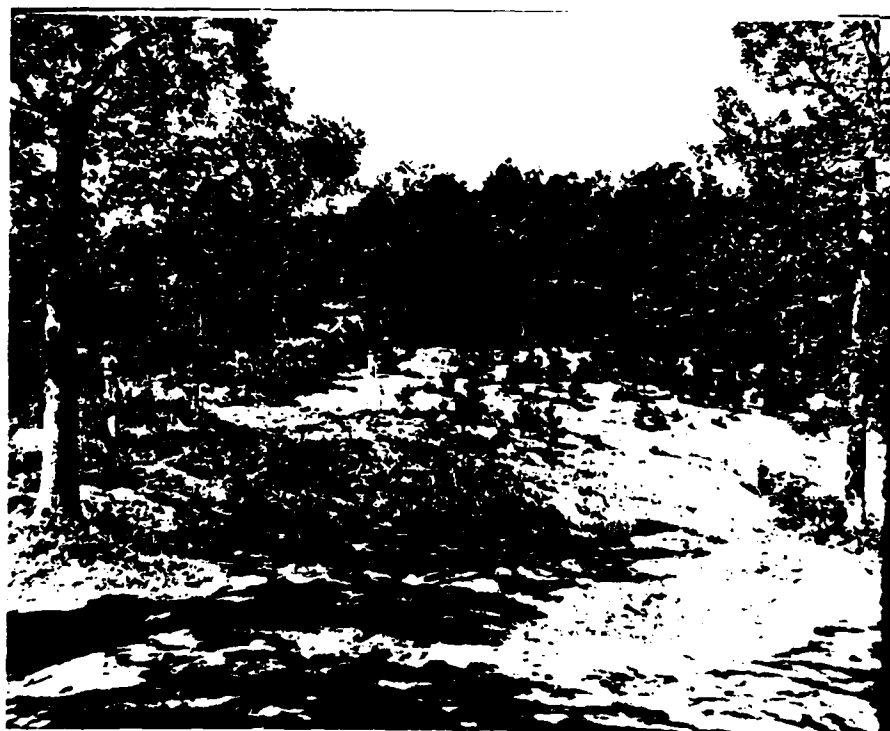
PHOTO 1 Butterfly Dam - d.s. side,
Emergency Spillway

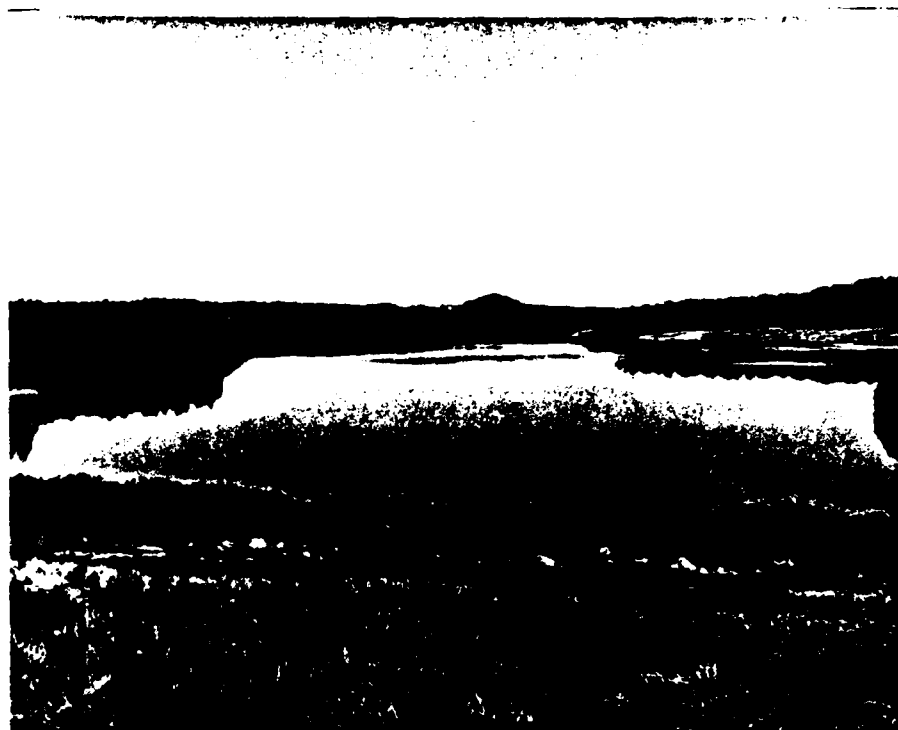
PHOTO 11 Rainbow Lake

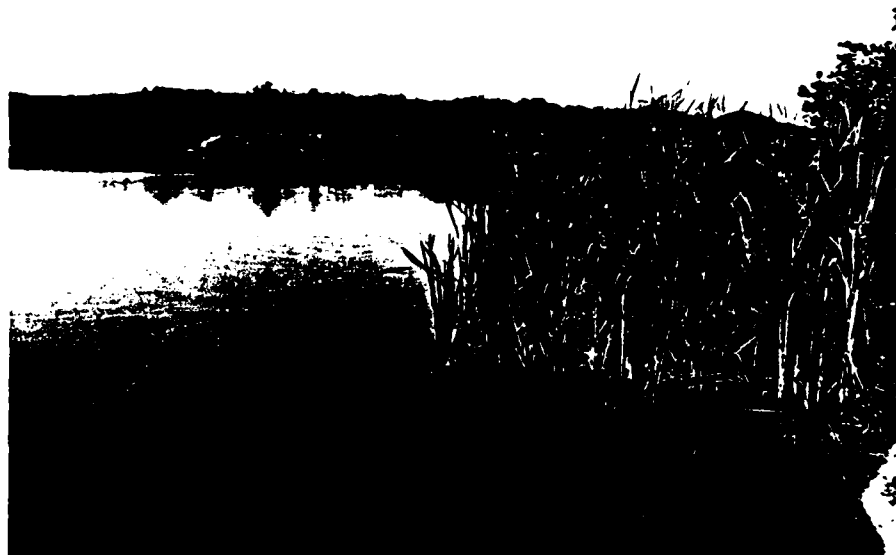
PHOTO 15 Rainbow Dam - Upstream Slope

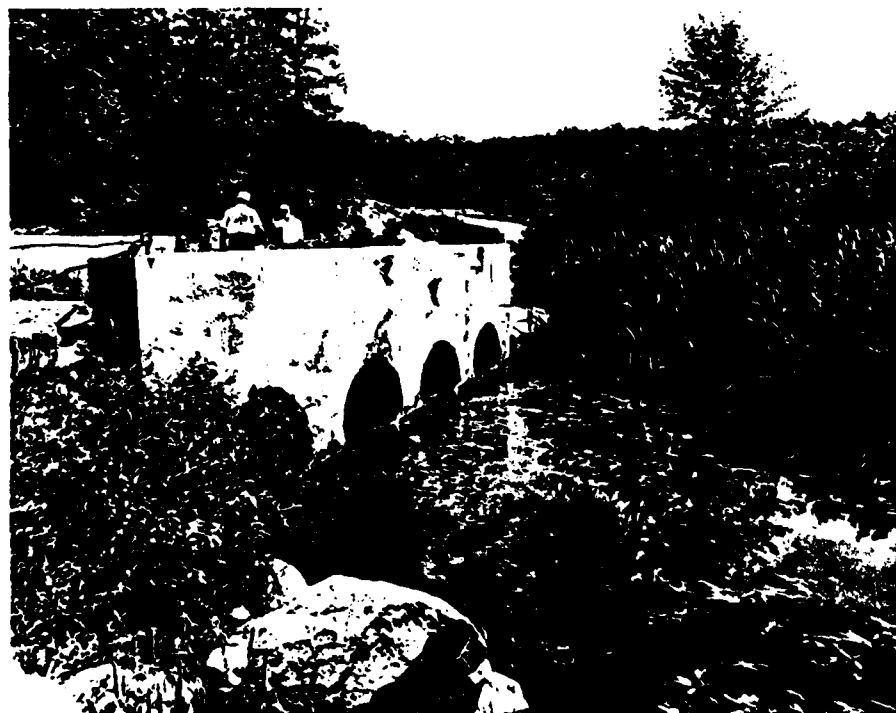
PHOTO 16 Rainbow Dam - Upstream Side
of Outlet
